BELZONA[®]
GREAT LAKES

**PETROCHEMICAL
FLANGE
ENCAPSULATION**

FLANGE ENCAPSULATION
OCTOBER, 2017

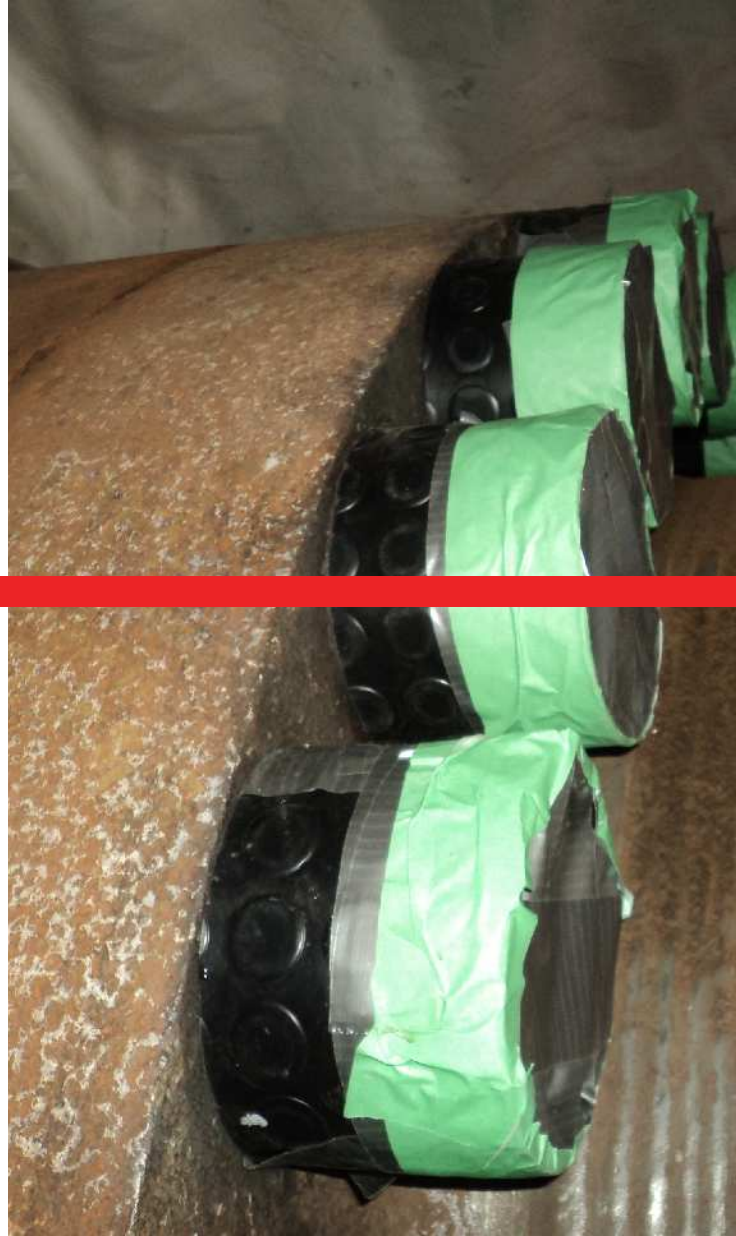
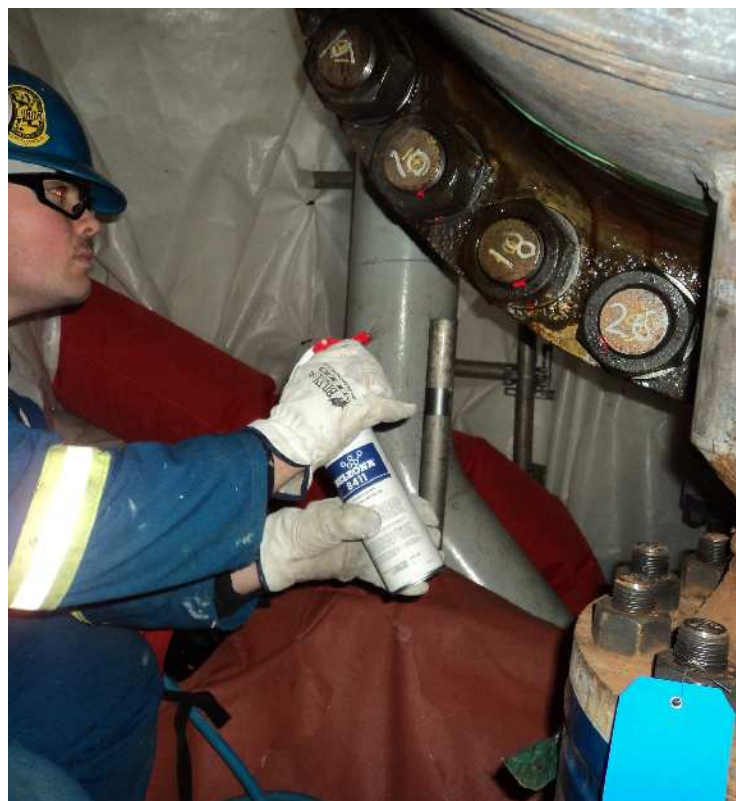
Customer based in Sarnia, Ontario was having corrosion problems in several flanges of his plant. The protective paint that was used in the past would peel off, exposing the substrate, which lead to corrosion around the flange, studs and nuts.

During shutdown, the maintenance staff was required to recoat the flange, thus they had to purchase new studs, nuts and be required to sandblast before coating. This process was costly, time consuming and did not provide the required level of protection.

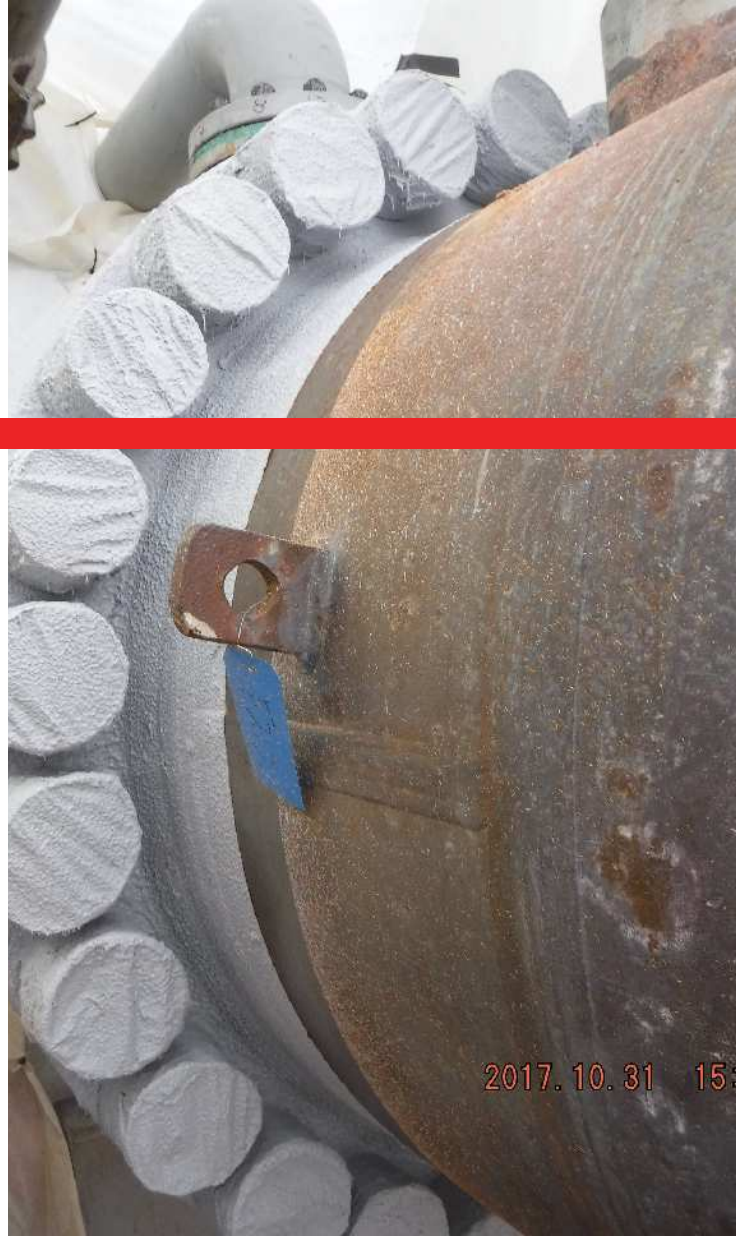
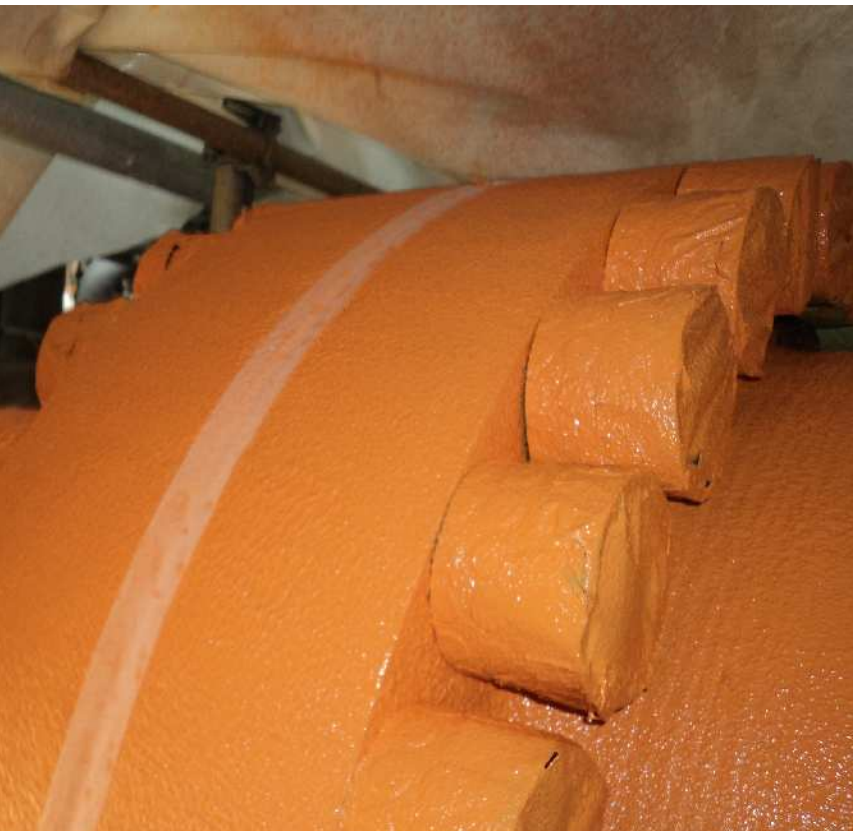
Before application of the product, the surface of the flanges was prepared and cleaned with power tools and cleaner degreaser. To seal the gap between the flange faces, a strip of bridging tape was used. Belzona 8411 was then applied to the entire application surface. After, rubber caps were installed over the bolts and nuts.

Belzona 3412 was then mixed and applied using a cartridge spray gun over most of the surface and with a short bristle brush over hard to reach areas. Two coats of dissimilar colors of Belzona 3412 were applied.

Belzona 3412 is a flexible encapsulating membrane, which protects flanges and equipment from moisture ingress, dust and the environment. This product when used in conjunction with Belzona 8411, a release agent/corrosion inhibitor, enables simple inspection by just cutting the system at the flanged joint and peeling it back. The system can also be resealed by simply adding a further layer of Belzona 3412.
