024/2021

RESIDENTIAL BUILDING
ROOF
LEAKING SUNROOM

LEAKING SUNROOM
JUNE, 2009

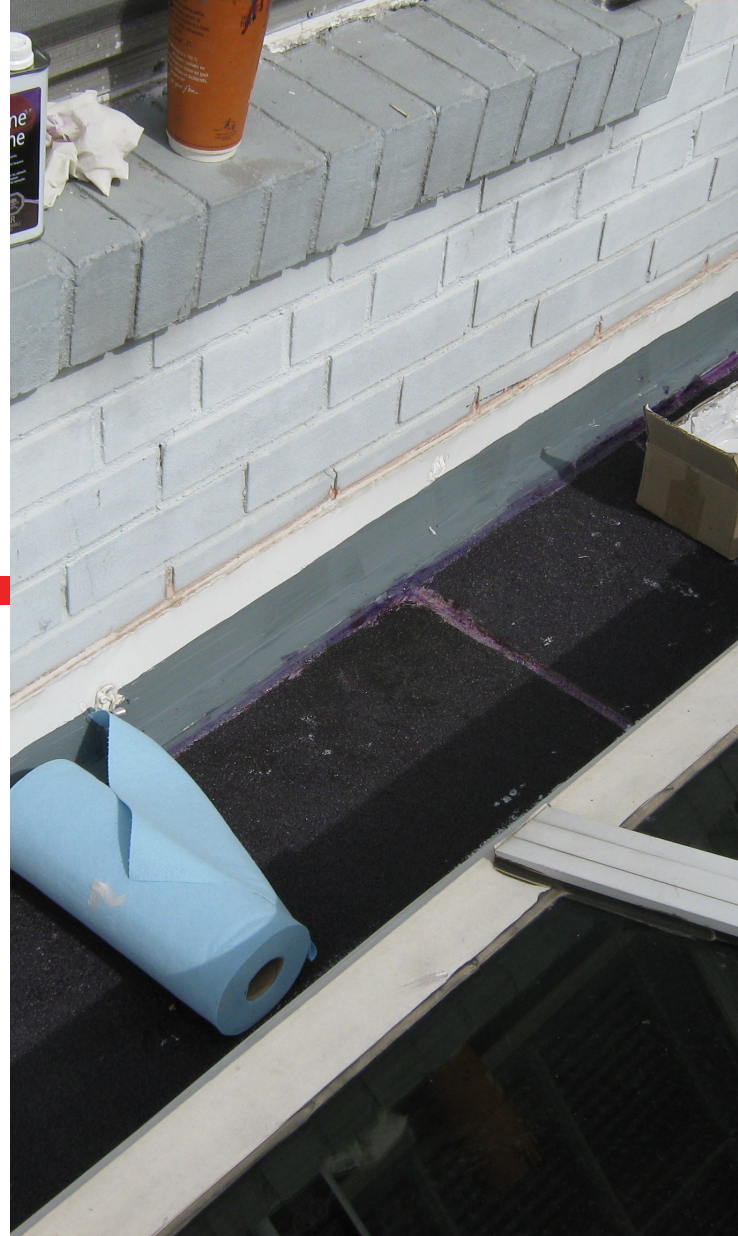
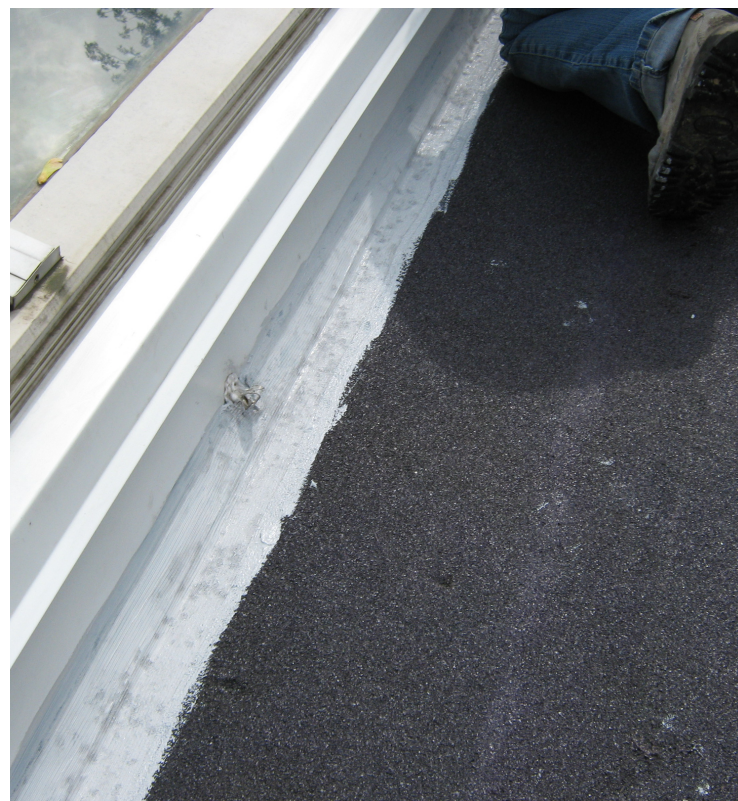
A residential customer in the city of Toronto was having problems with their sunroof. A poor roofing job left them with a leaking sunroom.

The roof and flashing on this customer sunroom was allowing water to permeate to the inside of their unit which was damaging their walls and belongings.

Belzona 3111 (Flexible Membrane) was specified to seal the leak source and to provide long term roof protection.

Before application of any Belzona product, the asphalt roof was cleaned and any blisters and bulges were cut out. After, Belzona 3911 (PSC Surface conditioner) was applied well into the surface and allowed to become touch dry. Then, Belzona 3111 (Flexible Membrane) was brush applied over the entire roof while embedding Belzona 9311 (Reinforcement Sheet).

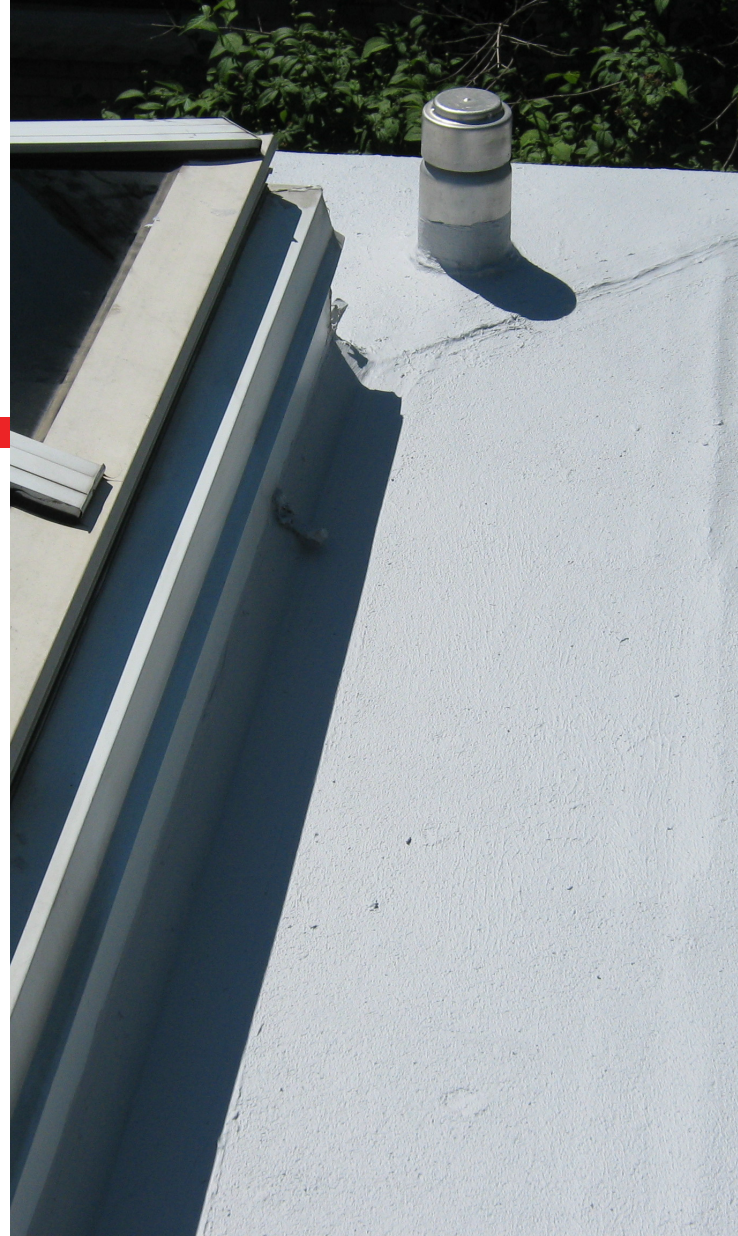
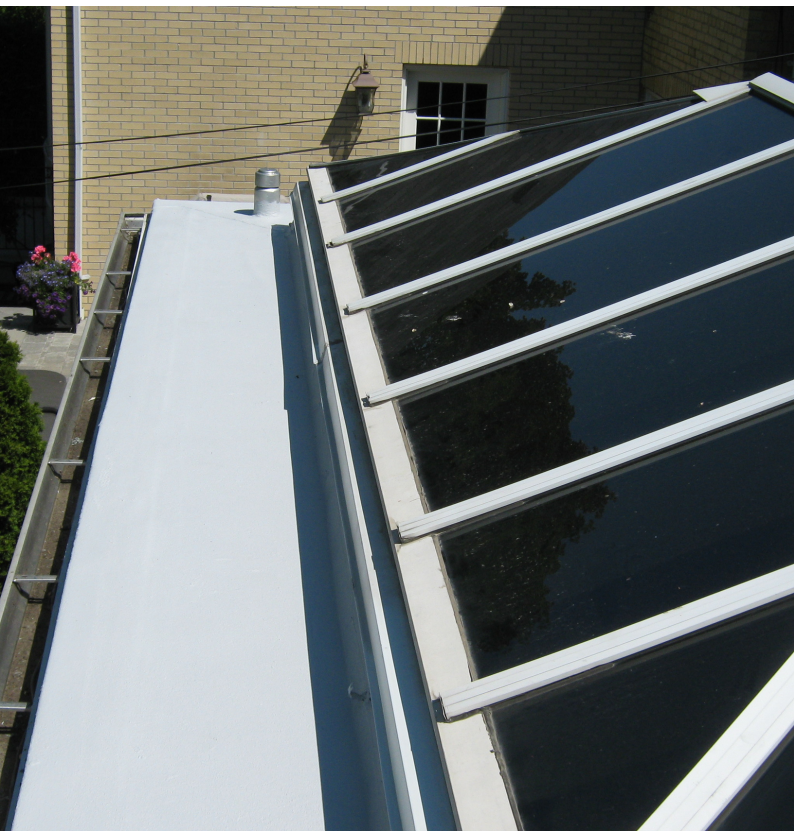
The application was completed in a timely manner and the sunroom roof was completely sealed and protected. The customer is now a Belzona believer.
