# Encapsulating membrane for flanges, fittings and connectors

# 3000 Series BELZONA 3412

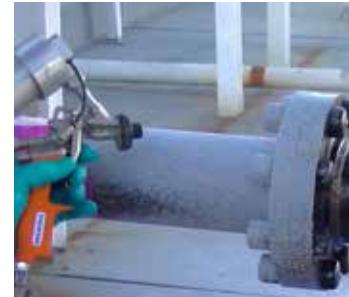
Belzona 3412 is applied as a two-coat system. See the Instructions for Use (IFU) for further application information.

Spray
